Manhole Inspection Summary

Manhole # S33II_008MH

Insp Date: **3/30/07 11:46 AM**

Location Address: **22 LOVEGROVE ST**

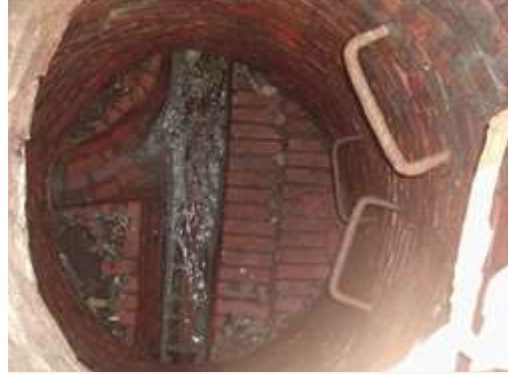
Top View

Corroded steps. Evidence of surcharge - Bench debris.

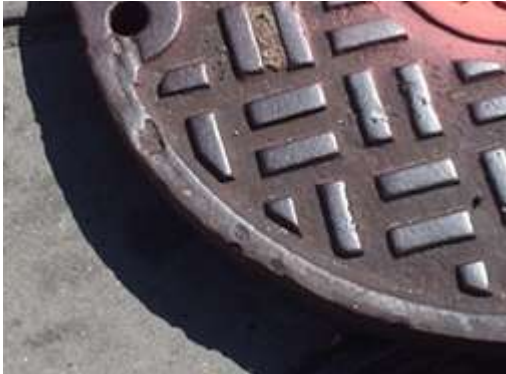
Defect

Worn cover.

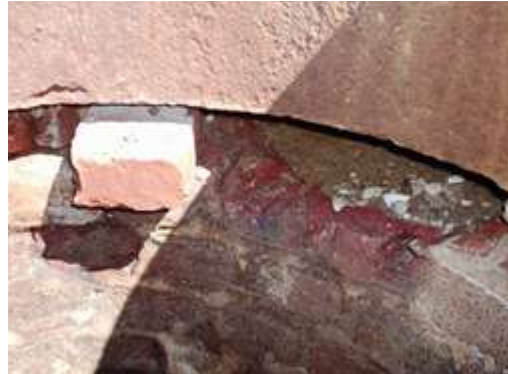
Defect

Adjustment deterioration, loose brick and infiltration.

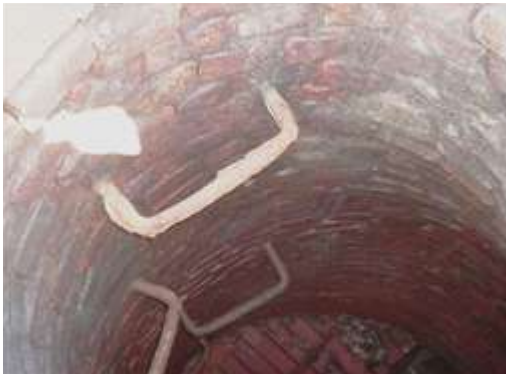
Defect

Adjustment deterioration and infiltration. Corbel infiltration.

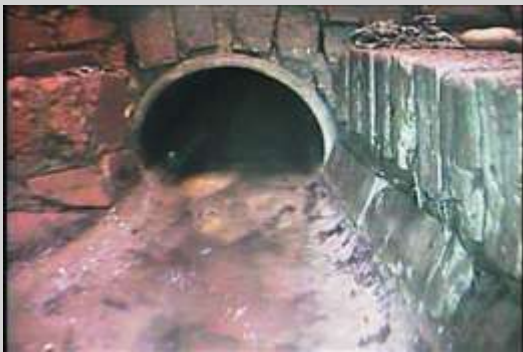
8 in. Circular Gravity Sewer Pipe Out @ 12 O'Clock

Barrel deterioration and infiltration. Channel deterioration.

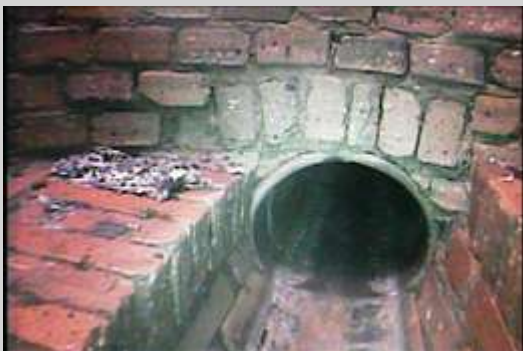
8 in. Circular Gravity Sewer Pipe In @ 6 O'Clock

Deposits: ☐ None ☐ Mud ☐ Sludge ☐ Debris ☒ Grease

Silt Depth: **0** (in.) Deposits Extent: **Light**

Infiltration: **Evidence** Pipe Seal Cond: **Cracked**

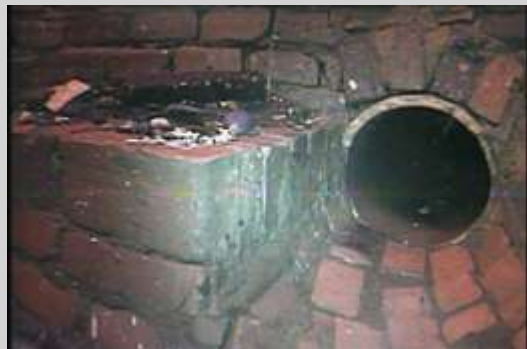
Pipe In @ 9 O'Clock

Barrel deterioration and infiltration. Channel deterioration.

Infiltration: **Evidence** Pipe Seal Cond: **Unknown**
